# REQUEST FOR PROPOSAL

## RUSTENBURG GIRLS HIGH SCHOOL SOLAR PROJECT

## **RUSTENBURG GIRLS' HIGH SCHOOL ROOFTOP SOLAR PHOTOVOLTAIC PROJECT**

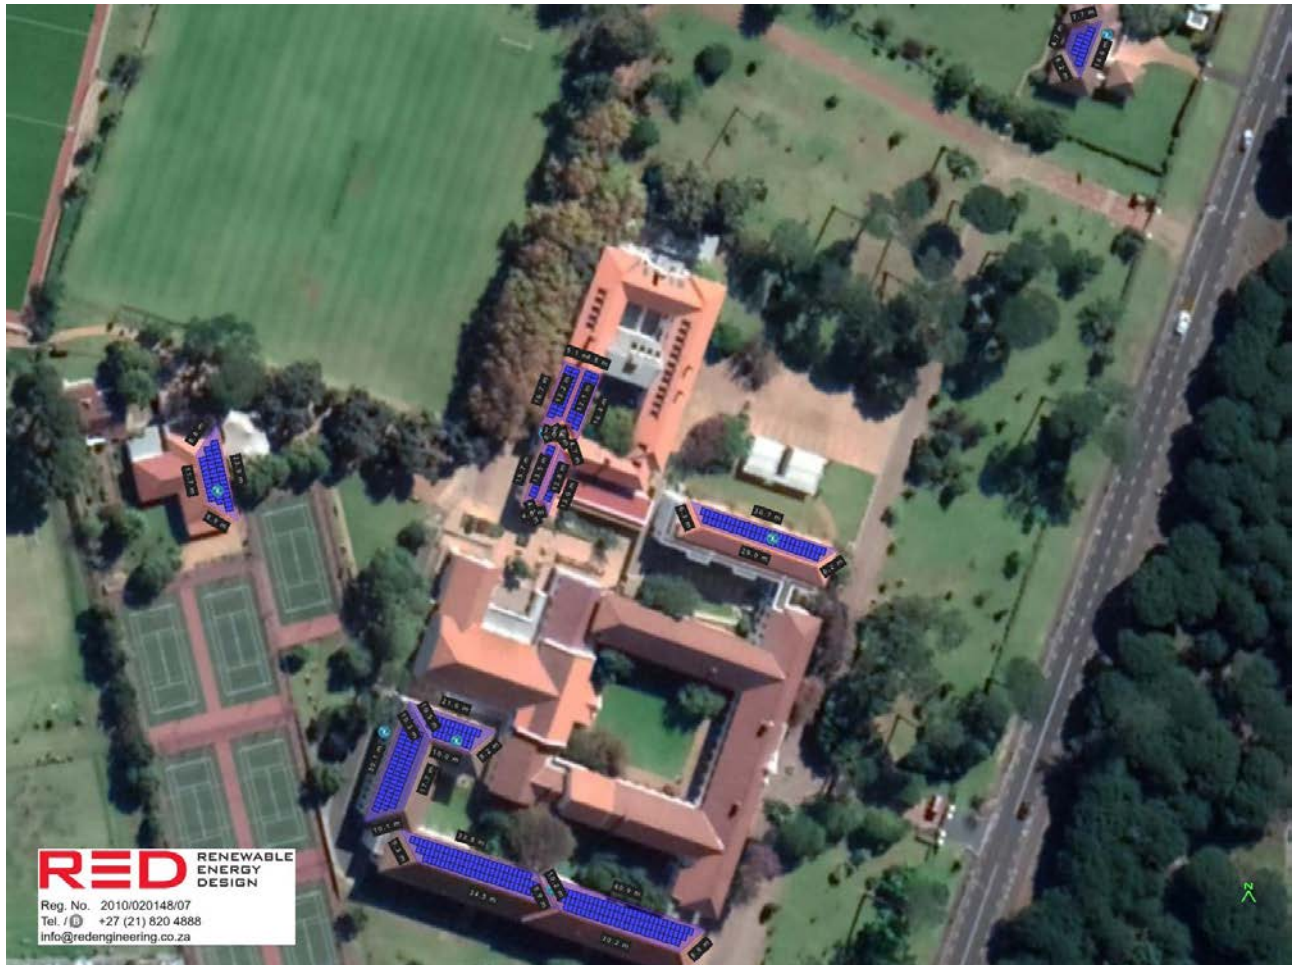
## Location for PV inverters

Inverters convert the DC current coming from the solar PV modules to AC current for use in the grid. Due to the distributed nature of the proposed system multiple inverters will be required. These will ideally be located as close to the sub distribution boards, they will be tied-in to, while keeping the DC cable runs as short as possible.
